SERVICE BULLETIN

No 331

Piper Aircraft Corporation

Subject: Electric Trim Switch Inspection and Modification

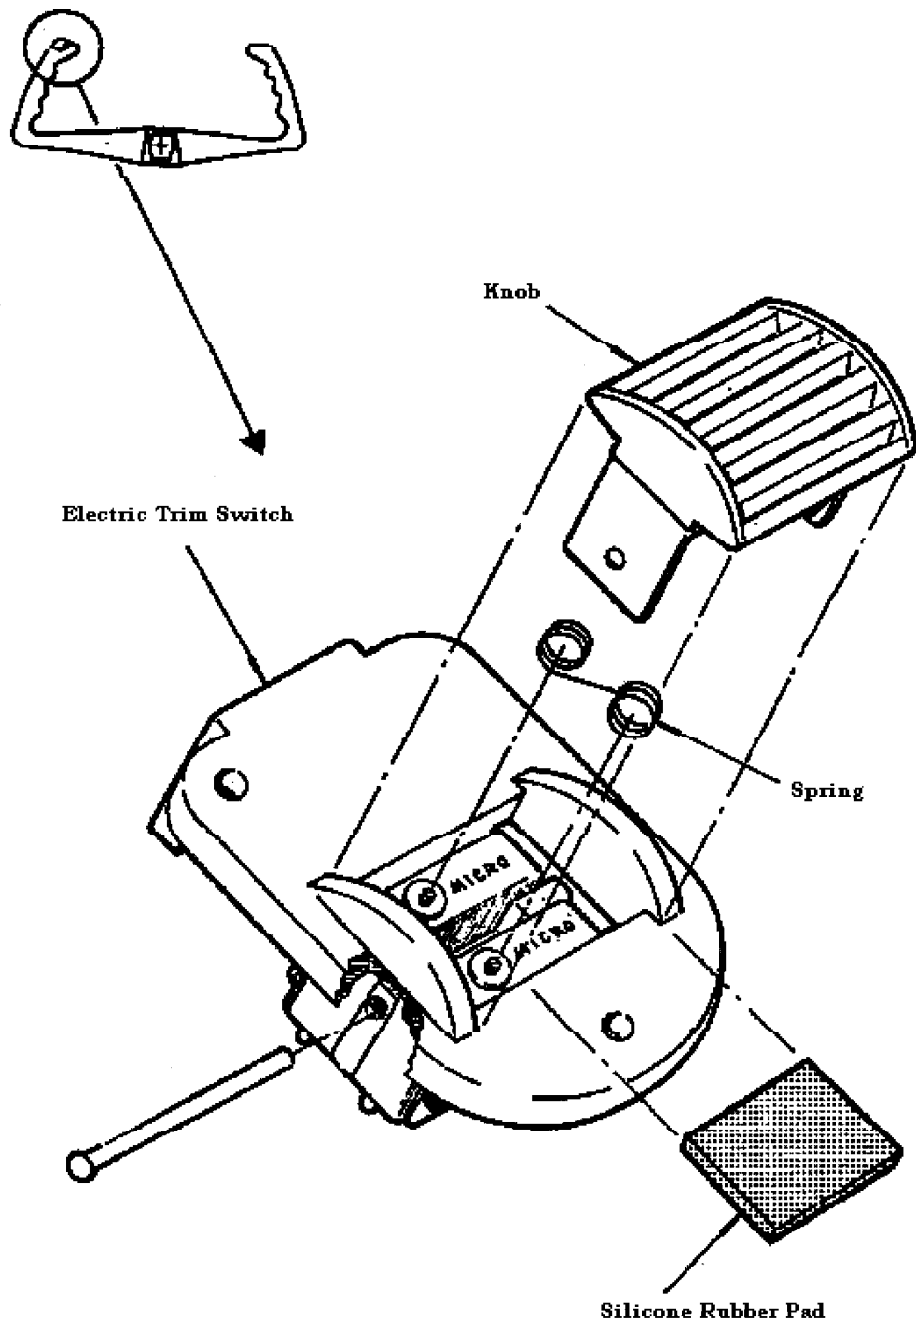
To modify the pilot's control wheel mounted "rocker" type trim switch by replacing the existing neutral return device (silicone rubber pad) with a coil spring (reference sketch below for a general description).

- I. Prior to each flight, inspect the pilot's control wheel mounted "rocker" type trim switch for proper operation per Instructions No. I, below;
- II. At the next 100 hour inspection or annual inspection (whichever occurs first), modify the trim switch in accordance with Piper Kit No. 760 505, Electric Trim Switch Modification.

One (1) each (per aircraft) Kit 760 505, Electric Trim Switch Modification.
