364A - PIPER

SERVICE LETTER

Detached or Loose Rubatex Blocks in Wing Panels

PA-24 and PA-24 "250" Comanches - Serial Nos. 24-1 to 24-2264 inclusive

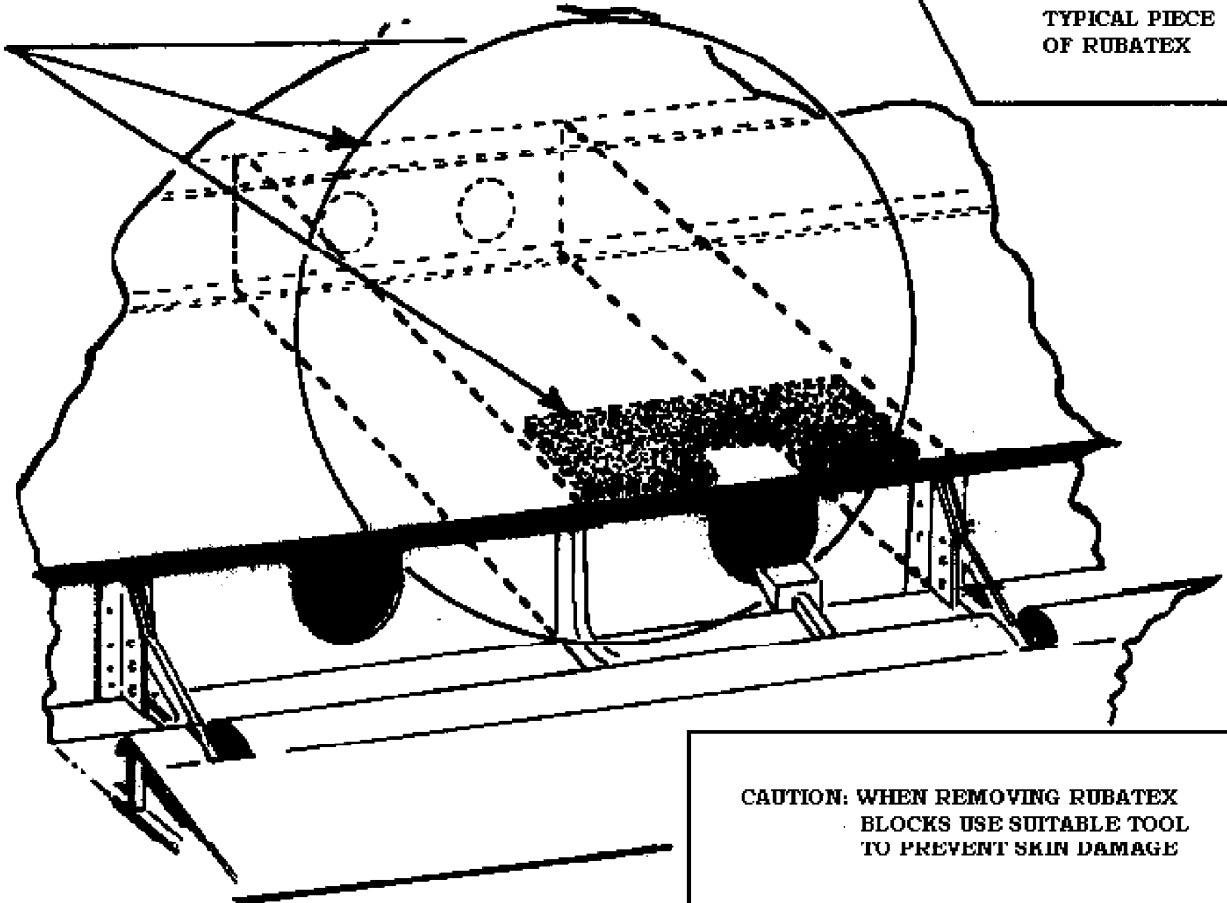
Sketch

Rubatex blocks were used in a few instances to reduce the tendency of oil canning in the areas of the wing panels, as shown on the sketch on the reverse side of this Service Letter. Prior to but not later than the next 50 hours of operation, this entire area on both wings must be inspected and where these blocks are observed either loose or attached, they are to be removed.

REMOVE ALL RUBATEX FOUND IN
THIS AREA UPPER AND LOWER SKINS

TYPICAL PIECE
OF RUBATEX

CAUTION: WHEN REMOVING RUBATEX
BLOCKS USE SUITABLE TOOL
TO PREVENT SKIN DAMAGE
