SERVICE LETTER NO. 379 - Piper

SERVICE LETTER *No. 379*

August 10, 1962

TO: Distributors, Dealers, Certified Service Centers and Owners
SUBJECT: Landing Gear Safety Switch Harness
MODELS AFFECTED: PA-24 and PA-24 "250" Comanches
Serial Numbers 24-1 to 24-3284 incl.

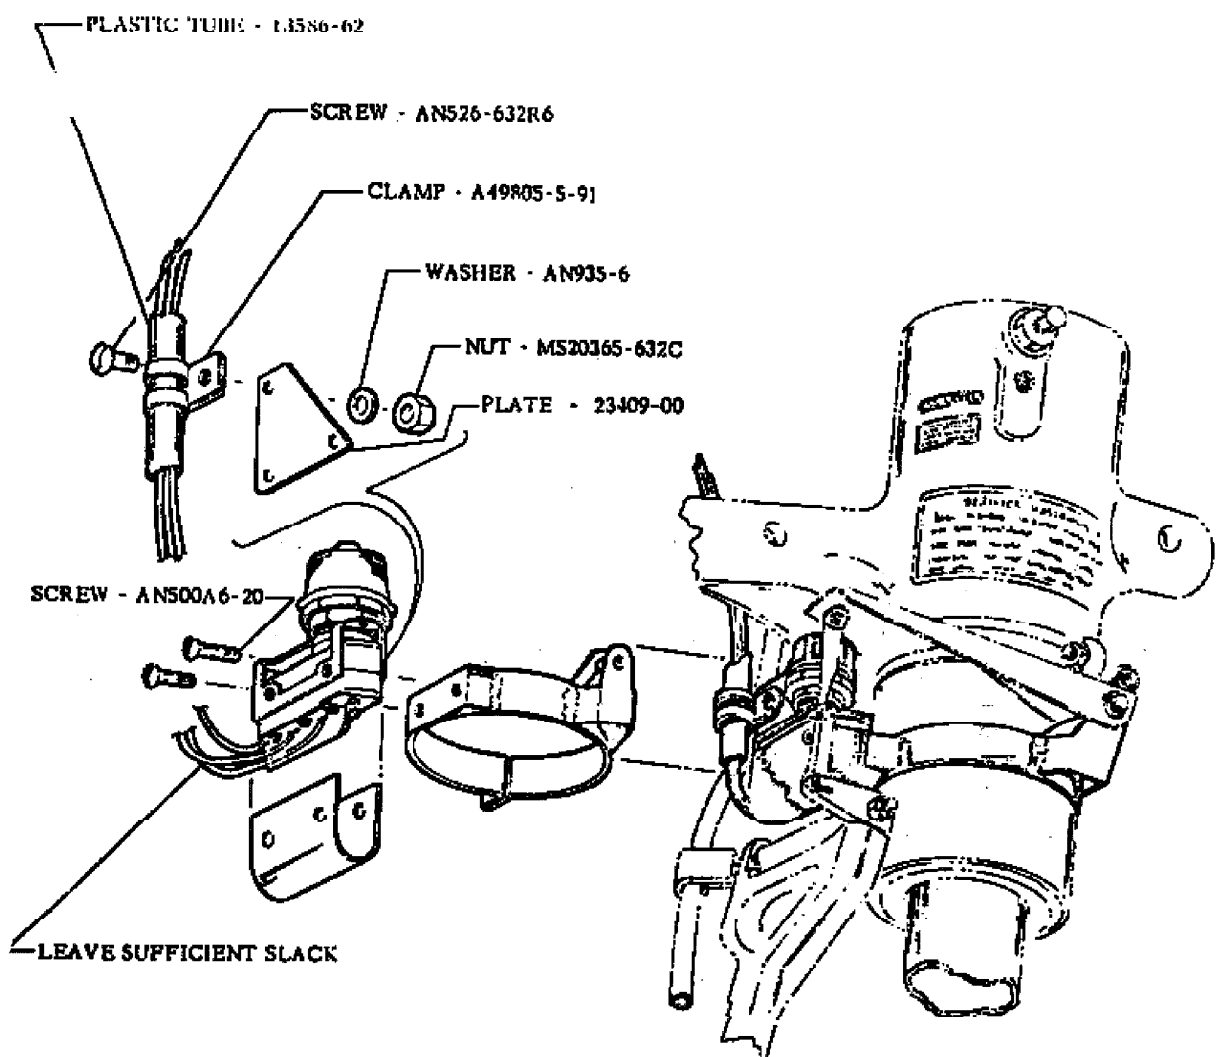
We have been advised that over extended periods of operation, there is a possibility of a wire or wires in the landing gear safety switch harness becoming broken at the switch. This condition would cause malfunction of the safety switch.

A kit, consisting of a bracket, clamp, plastic sleeve and necessary hardware, is available for use in the subject aircraft. It is recommended that this kit be installed in the referenced aircraft as it will support the wire harness of the safety switch. See sketch below in this Service Letter.

Until such time as this kit is installed, an inspection of the safety switch and related wire harness should be performed at each 100 hours of operation to ascertain this condition does not exist.

The part number of this kit is 754 475, unit price \$1.08, and is available through your Piper distributor or dealer.
