464A - Piper

Date:
March 22, 1976

SUBJECT:
Inspection of Stabilator Torque Tube Bearing Block Attachment Fitting Rivets.

MODELS AFFECTED:
PA-24-180, PA-24-250, and
PA-24-260 Comanche
PA-24-400 Comanche
PA-30 Twin Comanche
PA-39 Twin Comanche

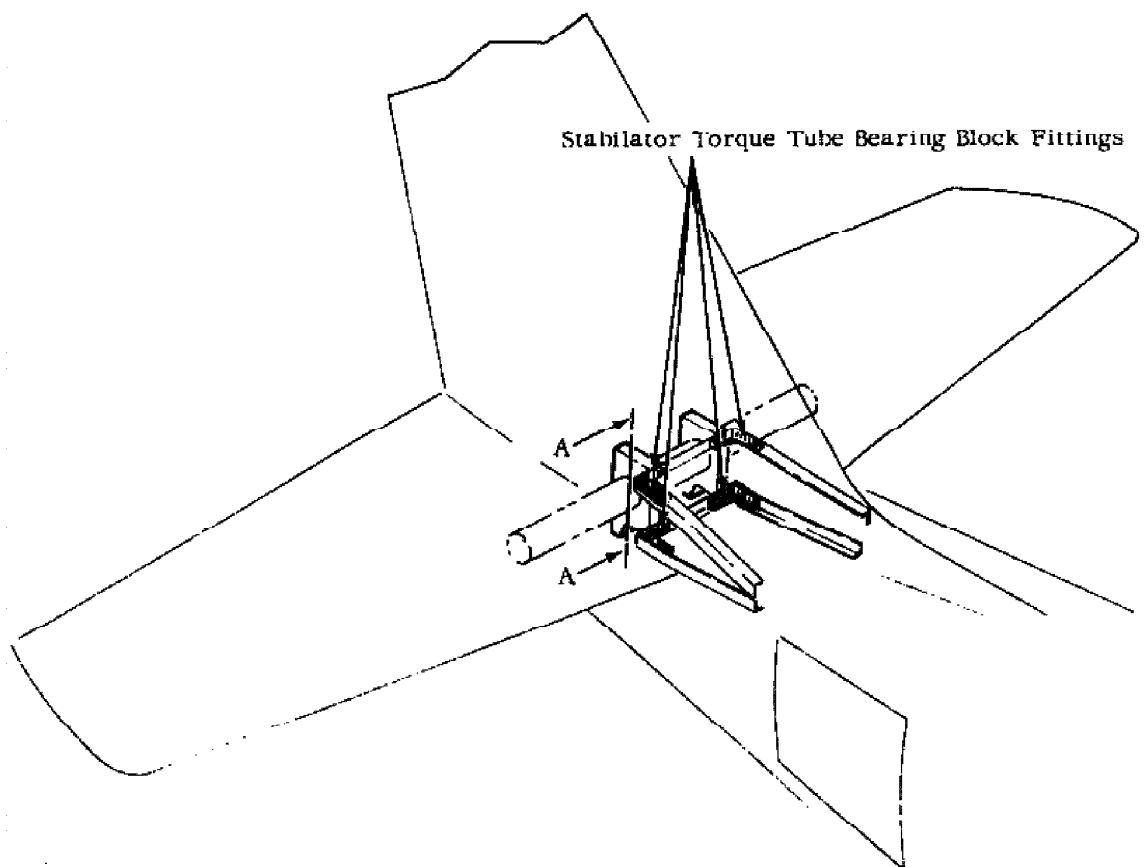
SKETCH

PURPOSE:
In some instances, while complying with Piper Service Bulletins Nos. 411 and 411A, it was determined that the rivets which attach the aft fuselage skin to the adjacent aft fuselage stringer align with some of the rivets which secure the Stabilator Torque Tube Bearing Block Attachment Fittings to the adjacent aft fuselage stringers. The fittings (particularly the lower fittings) are drilled to allow clearance for the heads of the rivets which attach the fuselage skin. In some cases, the rivet clearance holes were drilled too deep, thus allowing drill penetration of the Stabilator Bearing Block Attachment Fitting Rivets (see sketch for an illustration of this condition).

1. Remove the rear fuselage access panel located on the right side of the aircraft just forward of the stabilator.
2. Using a light and mirror (with extension), view through this access opening to determine if any of the horizontally positioned rivets through the skin align with any of the vertically positioned rivets in the bearing blocks (refer to sketch).

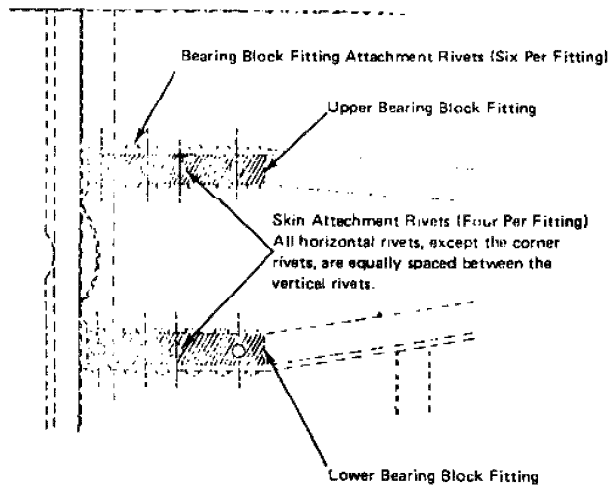
VIEW A-A: CORRECT RIVET ALIGNMENT

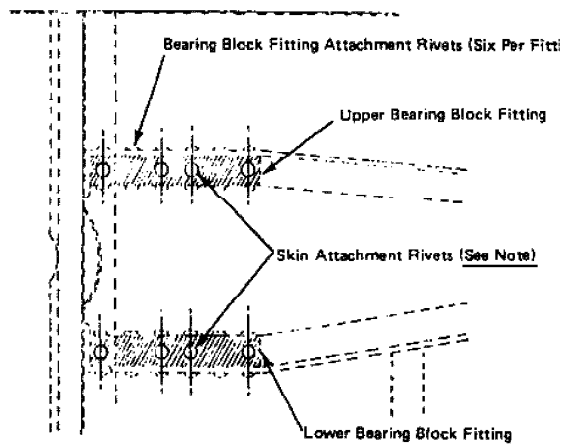
VIEW A-A: RIVET ALIGNMENT which may have resulted in rivet penetration:

NOTE: All horizontal rivets, except the corner rivets, are incorrectly installed in this view as they are aligned with the vertical rivets. If more than two rivet alignments are evident in each fitting, it will be necessary to install Kit 760 835.

3. If more than two (including the corner rivet) rivet alignments/penetrations in any bearing block fitting have been ascertained, installation of Kit Number 760 835 is required in the affected bearing block fitting. Two rivet alignments/penetrations or less as described in , paragraph 2. Purpose above, requires no further action except for the appropriate log book entry.
